Anthony Wayne Schools
Master Plan
02.06.2023

Anthony Wayne Local Schools

Monclova Elementary

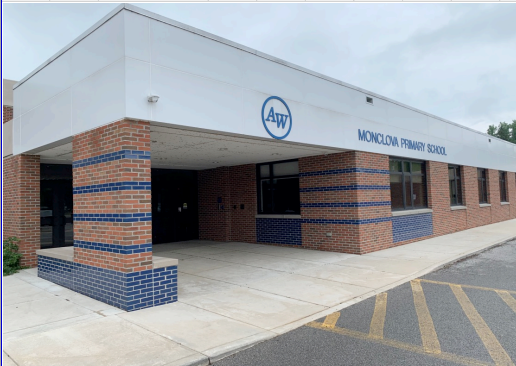
Priority Improvements - Monclova Elementary

Monclova Elementary		Auditor(s):	Date of Audit:
<p>The building is a single story educational facility serving Kindergarten through Fourth Grades. Construction includes steel frame and load bearing masonry with the exterior envelope comprised of a membrane roof, metal panel at the Entry, and brick & precast stone masonry veneer.</p>		Dave Serra / Mike DiNardo / Doug Hohman / Darren Keil	7/6/2022
Building Square Footages (GSF)			
1st Floor	51,400		
Total:	51,400		
Existing Building Data/ Statistics			
Year of Construction Completion:	1970's with later additions		
Stories:	1		
Use Group:	E - Education		
Structure:	Steel frame & load bearing masonry		
Exterior Enclosure:	Brick and Pre-Cast Stone Veneer		
Roof:	Membrane		
Elevator(s):	None		
Heating:	Electric		
Cooling:	DX Cooling		
Electric:			
Fire Suppression:	None		
Rating System			
1 = Replace			
2 = Poor			
3 = Adequate			
4 = New			
Building Systems Summary

Architectural Condition:	60%		
Life Safety / Code / Accessibility:	88%		
Structural:	63%		
Mechanical / Plumbing / Fire Protection:	48%		
Electrical:	36%		
Building Summary:	59%		
Color Rating Key			
Replace < 40%	Poor 40%-59%	Adequate 60-79%	Good 80% and Over

- Roof Replacement
- Exterior Wall Masonry Repairs
- Building Heating/Cooling System Replacement
- Electrical Distribution Replacement
- Building Lighting Replacement

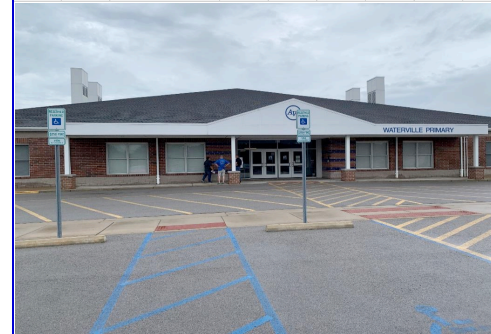
Priority Improvements - Waterville Elementary

Waterville Elementary		Auditor(s):	Date of Audit:
<p>The building is a single story educational facility serving Kindergarten through Fourth Grades. The original construction has seen one addition. Construction includes steel frame and load bearing masonry with the exterior envelope comprised of a single roof and brick/CMU masonry veneer with metal panel at the Entry.</p>		Dave Serra / Mike DiNardo / Doug Hohman / Darren Keil	7/6/2022
Building Square Footages (GSF)			
1st Floor	65,310		
Addition	6,547		
Total:	71,857		
Existing Building Data/ Statistics			
Year of Construction Completion:	1996 Original Building w/ Addition added in 2018		
Stories:	Single		
Use Group:	E - Education		
Structure:	Steel frame & load bearing masonry		
Exterior Enclosure:	Brick and Split Faced CMU veneer		
Roof:	Shingle		
Elevator(s):	None		
Heating:	Boiler		
Cooling:	Chiller		
Electric:			
Fire Suppression:	Yes		
Rating System

1 = Replace			
2 = Poor			
3 = Adequate			
4 = New			
Building Systems Summary			
Architectural Condition:	62%		
Life Safety / Code / Accessibility:	88%		
Structural:	69%		
Mechanical / Plumbing / Fire Protection:	66%		
Electrical:	40%		
Building Summary:	65%		
Color Rating Key			
Replace < 40%	Poor 40%-59%	Adequate 60-79%	Good 80% and Over

- Exterior Wall Masonry Repairs
- Exterior Wall and Window Sealing
- Building to Site Storm Water System Repairs
- Building Heating/Cooling System Replacement
- Building Lighting Replacement

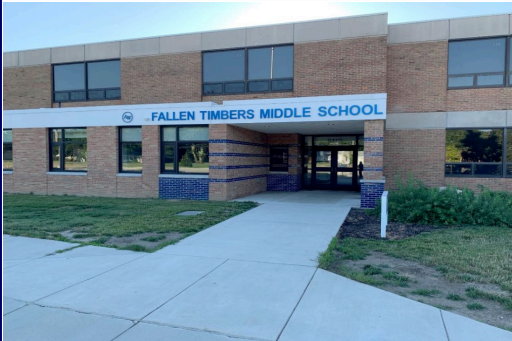
Priority Improvements - Fallen Timbers

Fallen Timbers Middle School		Date of Audit:	7/12/2022
Auditor(s): Dave Serra / Mike DiNardo / Doug Hohman / Darren Keil			
The building is single-two story educational facility serving the fifth and sixth grades. The facility has received additions with the most recent being completed in 2019. Construction includes steel frame and load bearing masonry with the exterior envelope comprised of a membrane roof, metal panel at Entry, and brick & precast stone masonry veneer.			
Building Square Footages (GSF)			
1st Floor		42,100	
2nd Floor		18,000	
Total:		60,100	
Existing Building Data/Statistics			
Year of Construction Completion:		1973 with later additions	
Stories:		2	
Use Group:		E - Education	
Structure:		Steel frame & load bearing masonry	
Exterior Enclosure:		Brick and Precast Stone Veneer	
Roof:		Membrane	
Elevator(s):		1	
Heating:		Unit Vents + Boiler System	
Cooling:		Chiller	
Electric:			
Fire Suppression:		None

Rating System			
1 = Replace			
2 = Poor			
3 = Adequate			
4 = New			
Building Systems Summary			
Architectural Condition:		72%	
Life Safety / Code / Accessibility:		63%	
Structural:		75%	
Mechanical / Plumbing / Fire Protection:		45%	
Electrical:		48%	
Building Summary:		60%	
Color Rating Key			
Replace	< 40%	Poor	40%-59%
Adequate	60-79%	Good	80% and Over

- Exterior Wall Masonry Repairs
- Exterior Wall Window/Louver Flashing Repairs
- Cooling System Chiller Replacement
- Heating System Piping Replacement
- Building Lighting Replacement

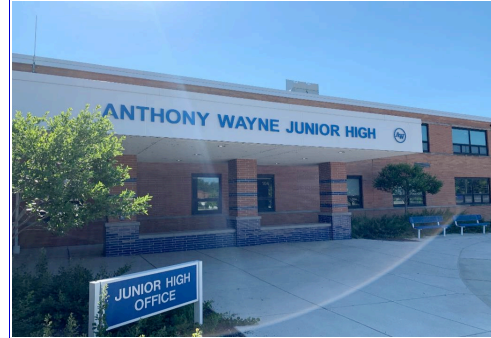
Priority Improvements - Junior High School

Junior High School		Date of Audit:	7/12/2022
Auditor(s): Dave Serra / Mike DiNardo / Joe Adams / Doug Hohman / Darren Keil			
The building is single-two story educational facility serving the seventh and eighth grades. The facility has received additions with the most recent being completed in 2019. Construction includes steel frame and load bearing masonry with the exterior envelope comprised of a membrane roof, metal panel at the Entry, and brick & precast stone masonry veneer.			
Building Square Footages (GSF)			
1st Floor		53,700	
2nd Floor		23,000	
Total:		76,700	
Existing Building Data/Statistics			
Year of Construction Completion:		1959 with later additions	
Stories:		2	
Use Group:		E - Education	
Structure:		Steel frame & load bearing masonry	
Exterior Enclosure:		Brick and Pre-Cast Stone Veneer	
Roof:		Membrane	
Elevator(s):		1	
Heating:		Boilers	
Cooling:		Chiller w/ice Storage	
Electric:			
Fire Suppression:		None

Rating System			
1 = Replace			
2 = Poor			
3 = Adequate			
4 = New			
Building Systems Summary			
Architectural Condition:		62%	
Life Safety / Code / Accessibility:		84%	
Structural:		75%	
Mechanical / Plumbing / Fire Protection:		41%	
Electrical:		47%	
Building Summary:		62%	
Color Rating Key			
Replace	< 40%	Poor	40%-59%
Adequate	60-79%	Good	80% and Over

- Roof Replacement
- Exterior Wall Masonry Repairs
- Building Cooling System Replacement
- Building Heating/Cooling System Control Replacement
- Building Lighting Replacement

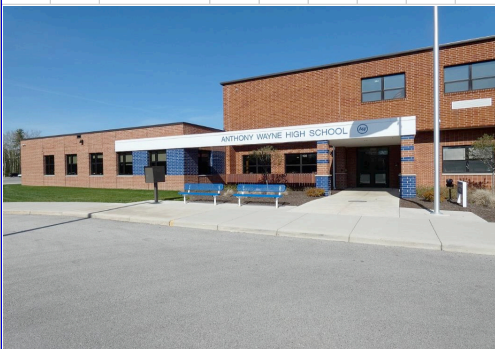
Priority Improvements - High School

High School	
Auditor(s): Dave Serra / Joe Adams / Doug Hohman / Darren Keil	Date of Audit: 8/2/2022
The building is single/two story educational facility serving grades 9th through 12th. The facility has received additions with the most recent being completed in 2019. Construction includes steel frame and load bearing masonry with the exterior envelope comprised of a membrane roof, metal panel at the Entry, and brick masonry veneer.	
Building Square Footages (GSF)	
1st Floor	185,000
2nd Floor	21,700
Total:	206,700
Existing Building Data/ Statistics	
Year of Construction Completion:	
Stories:	2
Use Group:	E - Education
Structure:	Steel frame & load bearing masonry
Exterior Enclosure:	Masonry
Roof:	Membrane
Elevator(s):	1
Heating:	Boilers with RTU
Cooling:	Chiller
Electric:	
Fire Suppression:	N/A
Rating System	
1 = Replace	
2 = Poor	
3 = Adequate	
4 = New	
Building Systems Summary	
Architectural Condition:	66%
Life Safety / Code / Accessibility:	73%

Structural:	75%
Mechanical / Plumbing / Fire Protection:	55%
Electrical:	50%
Building Summary:	64%
Color Rating Key	
Replace < 40%	Poor 40%-59%
Adequate 60-79%	Good 80% and Over

- Roof Replacement
- Exterior Wall Masonry Repairs
- Main Office Door Modifications
- Building Heating/Cooling System Component Replacement
- Building Lighting Replacement

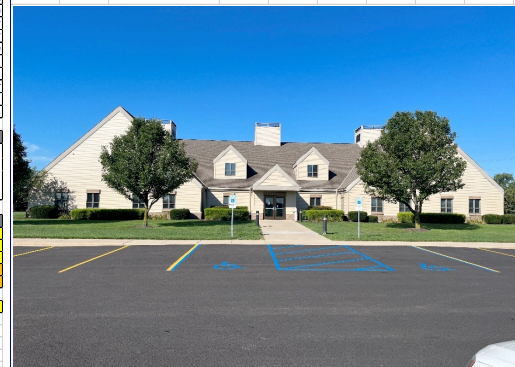
Priority Improvements - Central Administration

Administration Building	
Auditor(s): Joe Adams / Doug Hohman / Darren Keil	Date of Audit: 8/17/2022
The building has two stories with only the 1st floor being finished and occupied. The second floor remains in rough construction and primarily used for storage. Construction includes wood and metal stud wall framing with wood roof trusses. The exterior envelope is comprised of a shingle roof and cement siding on the exterior walls.	
Building Square Footages (GSF)	
1st Floor	12,300
2nd Floor (Unfinished)	
Total:	12,300
Existing Building Data/ Statistics	
Year of Construction Completion:	2005
Stories:	2
Use Group:	B - Business
Structure:	Wood & Metal Stud
Exterior Enclosure:	Cement Siding
Roof:	Shingle
Elevator(s):	N/A
Heating:	Furnace
Cooling:	Condensing Units
Electric:	
Fire Suppression:	N/A
Rating System	
1 = Replace	
2 = Poor	
3 = Adequate	
4 = New	
Building Systems Summary	
Architectural Condition:	64%
Life Safety / Code / Accessibility:	63%

Structural:	69%
Mechanical / Plumbing / Fire Protection:	0%
Electrical:	0%
Building Summary:	53%
Color Rating Key	
Replace < 40%	Poor 40%-59%
Adequate 60-79%	Good 80% and Over

- Site/Entry Drive Repairs
- Roof Replacement
- Roof Chimney Feature Repairs
- Elevator Installation
- Building Lighting Replacement

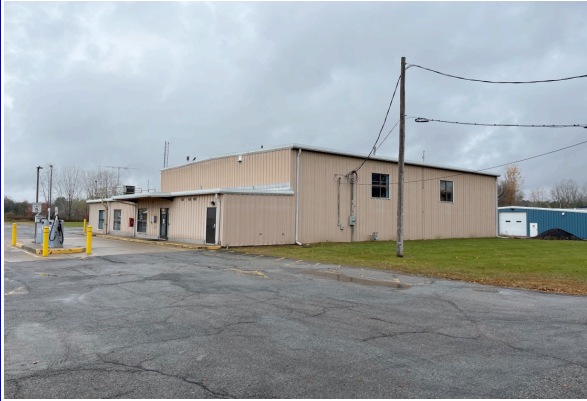
Priority Improvements - Transportation Building

Transportation Building			
Auditor(s): Joe Adams / Doug Hohman / Darren Keil	Date of Audit: 10/31/2022		
<p>The building has two stories with the 1st floor including service bays and office space. The 2nd floor includes a Lunch Room/Lounge and Storage Mezzanine for the service bays. Construction is a pre-engineered metal building with structural steel framing. The exterior envelope is comprised of metal wall and roof panels. The site asphalt areas are failing and are in need of replacement.</p>			
Building Square Footages (GSF)			
1st Floor	5,776		
2nd Floor (Partially Finished and Storage Loft)	1,463		
Total:	7,239		
Existing Building Data/ Statistics			
Year of Construction Completion:	1985 with Addition in 2001		
Stories:	2		
Use Group:	S-1		
Structure:	Steel		
Exterior Enclosure:	Metal Siding		
Roof:	Standing Seam Metal		
Elevator(s):	N/A		
Heating:	RTU		
Cooling:	RTU		
Electric:			
Fire Suppression:	N/A

Rating System			
1 = Replace			
2 = Poor			
3 = Adequate			
4 = New			
Building Systems Summary			
Architectural Condition:	39%		
Life Safety / Code / Accessibility:	44%		
Structural:	75%		
Mechanical:	64%		
Electrical:	46%		
Building Summary:	54%		
Color Rating Key			
Replace < 40%	Poor 40%-59%	Adequate 60-79%	Good 80% and Over

- Site/Asphalt Repairs
- Exterior Wall Metal Panel Replacement
- Overhead Door Replacement
- Building Heating/Cooling System Component Replacement
- Building Lighting Replacement
