Anthony Wayne Local Schools

Auditor(s): Dave Serra / Mike DiNardo / Doug Hohman / Darren Keil

7/6/2022

Monclova Elementary

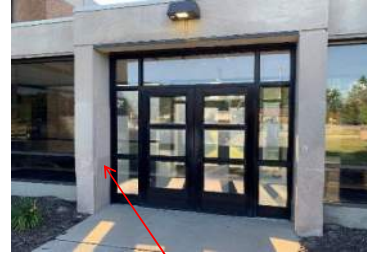
Staining on masonry.

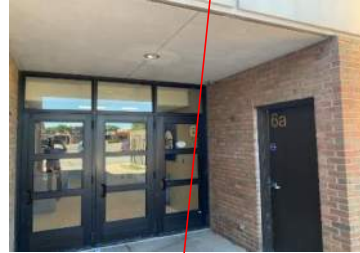
Need repairs below windows.

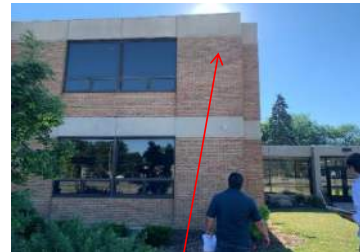
Rusted louver.

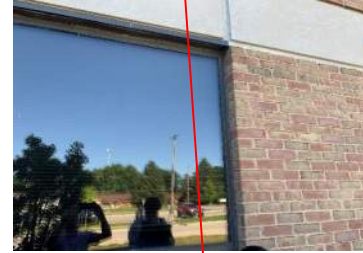
Reseal window.

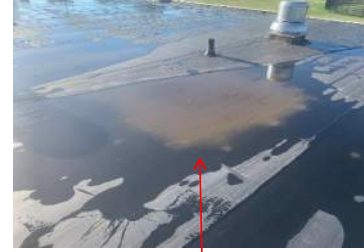
Failing roof cement/joints.

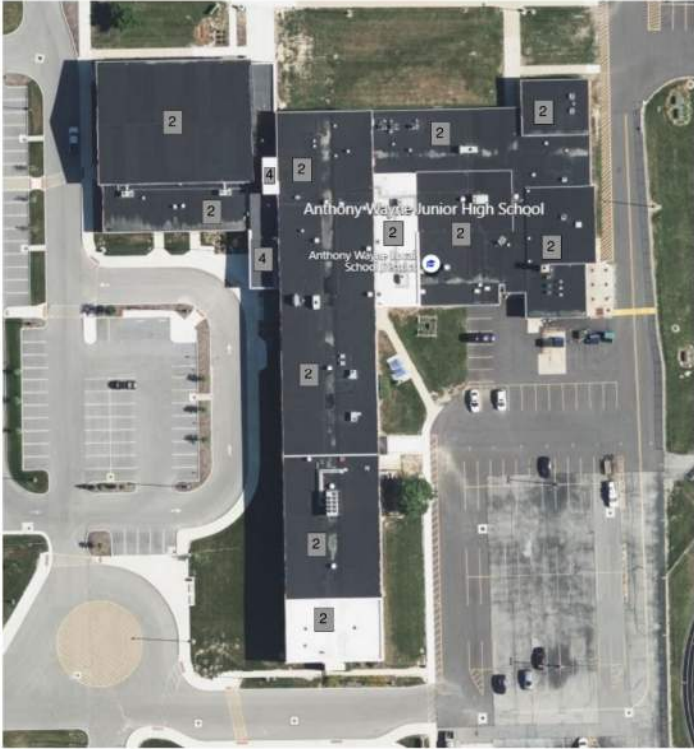
Roof Plan

Roofing joint/seam cracking needing repair.

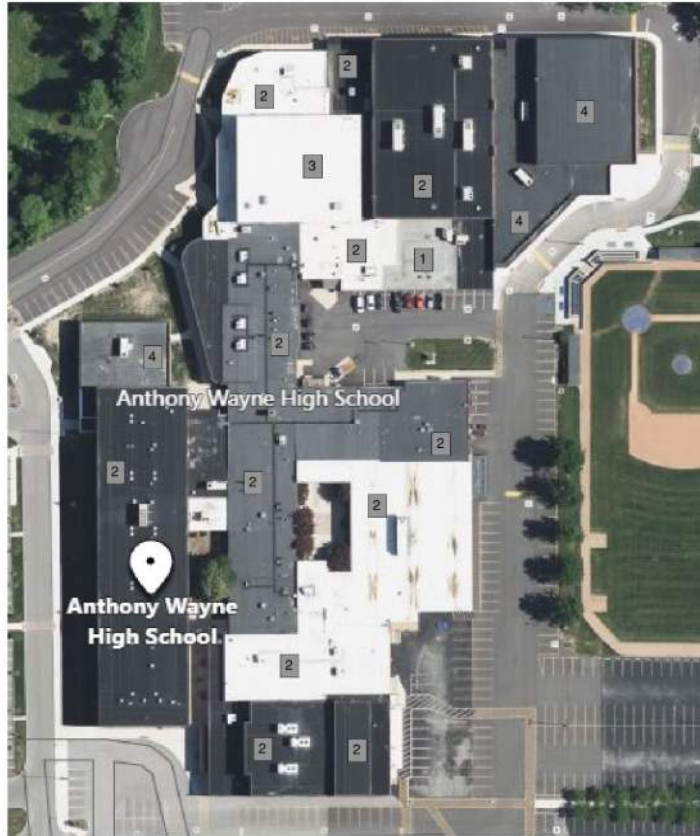
Roof Plan

Damaged roof coping.

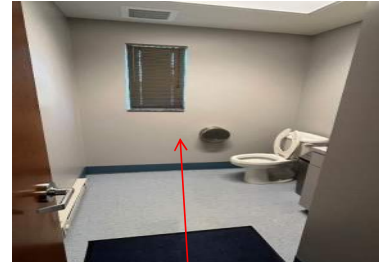
Restroom not ADA compliant

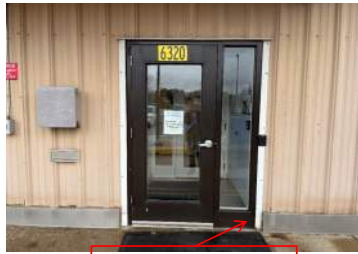
Rusting Door Frame

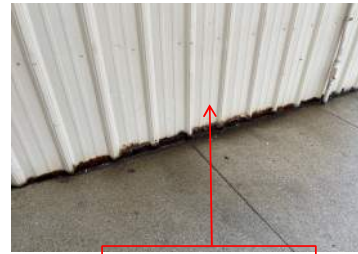
Rusting Metal Siding

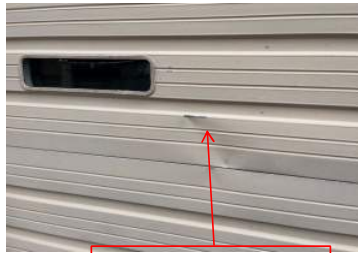
Damaged O.H. Door

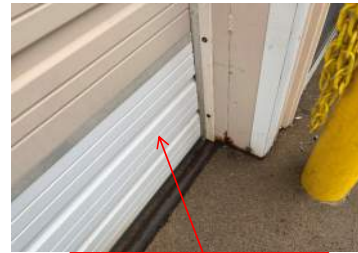
Different Color Door Section

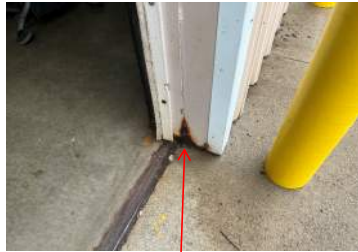
Rusting O.H. Door Frame/Jamb

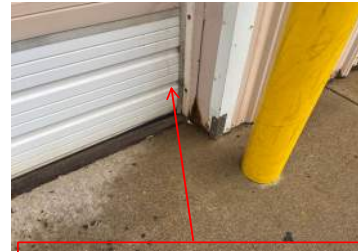
Different Color O.H. Door Section and Rusting O.H. Door Frame/Jamb

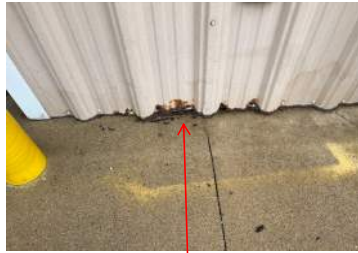
Rusting Metal Siding

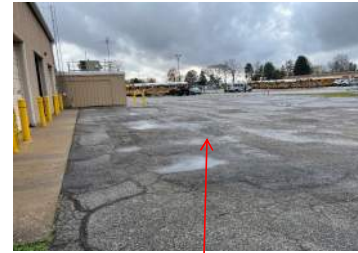
Poor Asphalt Condition

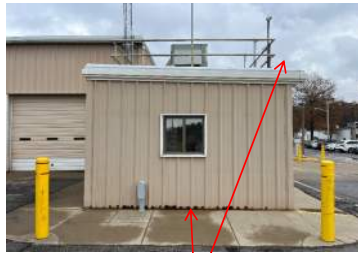
Rusting Metal Siding -
Paint Roof Guard

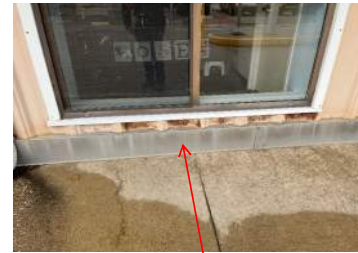
Rusting Metal Siding

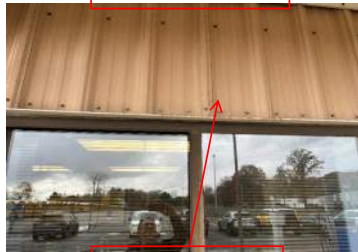
Rusting Metal

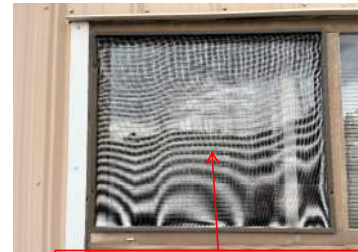
Damaged Screen & Failing Sealant

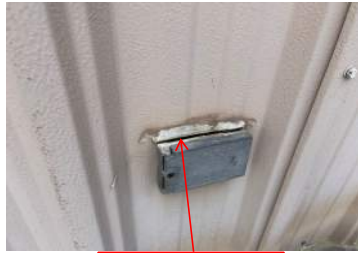
Failing Sealant

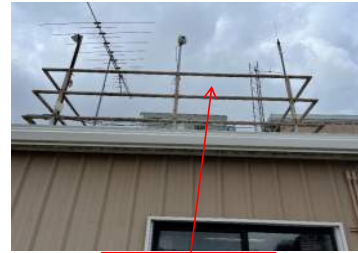
Paint Roof Guard

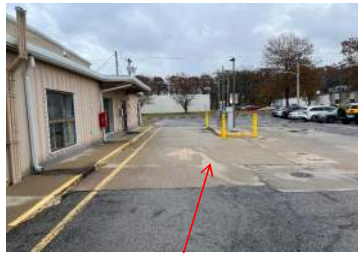
Poor Concrete Paving Condition

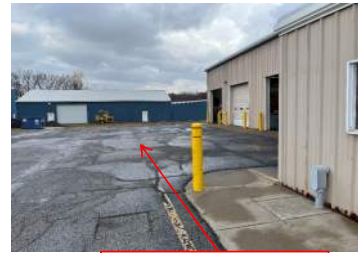
Poor Asphalt Condition

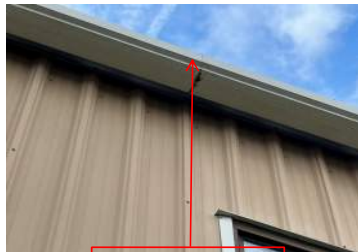
Leaking Gutter

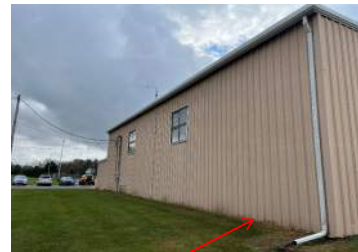
Rusting Metal Panels

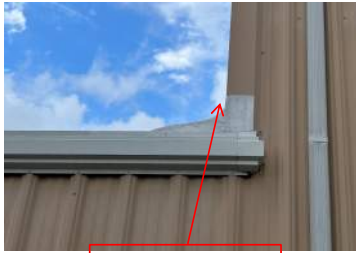
Roof Coating

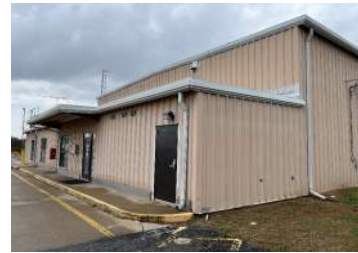
Rusting Steel Framing

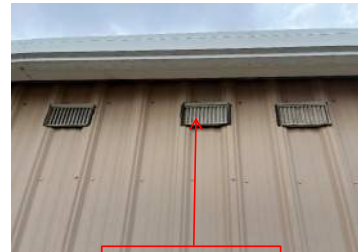
Replace Louvers

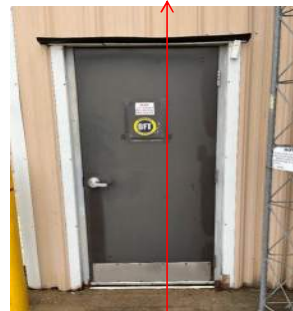
Damaged Door Head
